NAVAL STATION TREASURE ISLAND  
SAN FRANCISCO, CALIFORNIA

SITE INSPECTION REPORT

Department of the Navy  
Western Division  
Naval Facilities Engineering Command  
San Bruno, California 94066-0727

**PRC ENVIRONMENTAL MANAGEMENT, INC.  
120 Howard Street, Suite 700  
San Francisco, CA 94105  
415/543-4880**

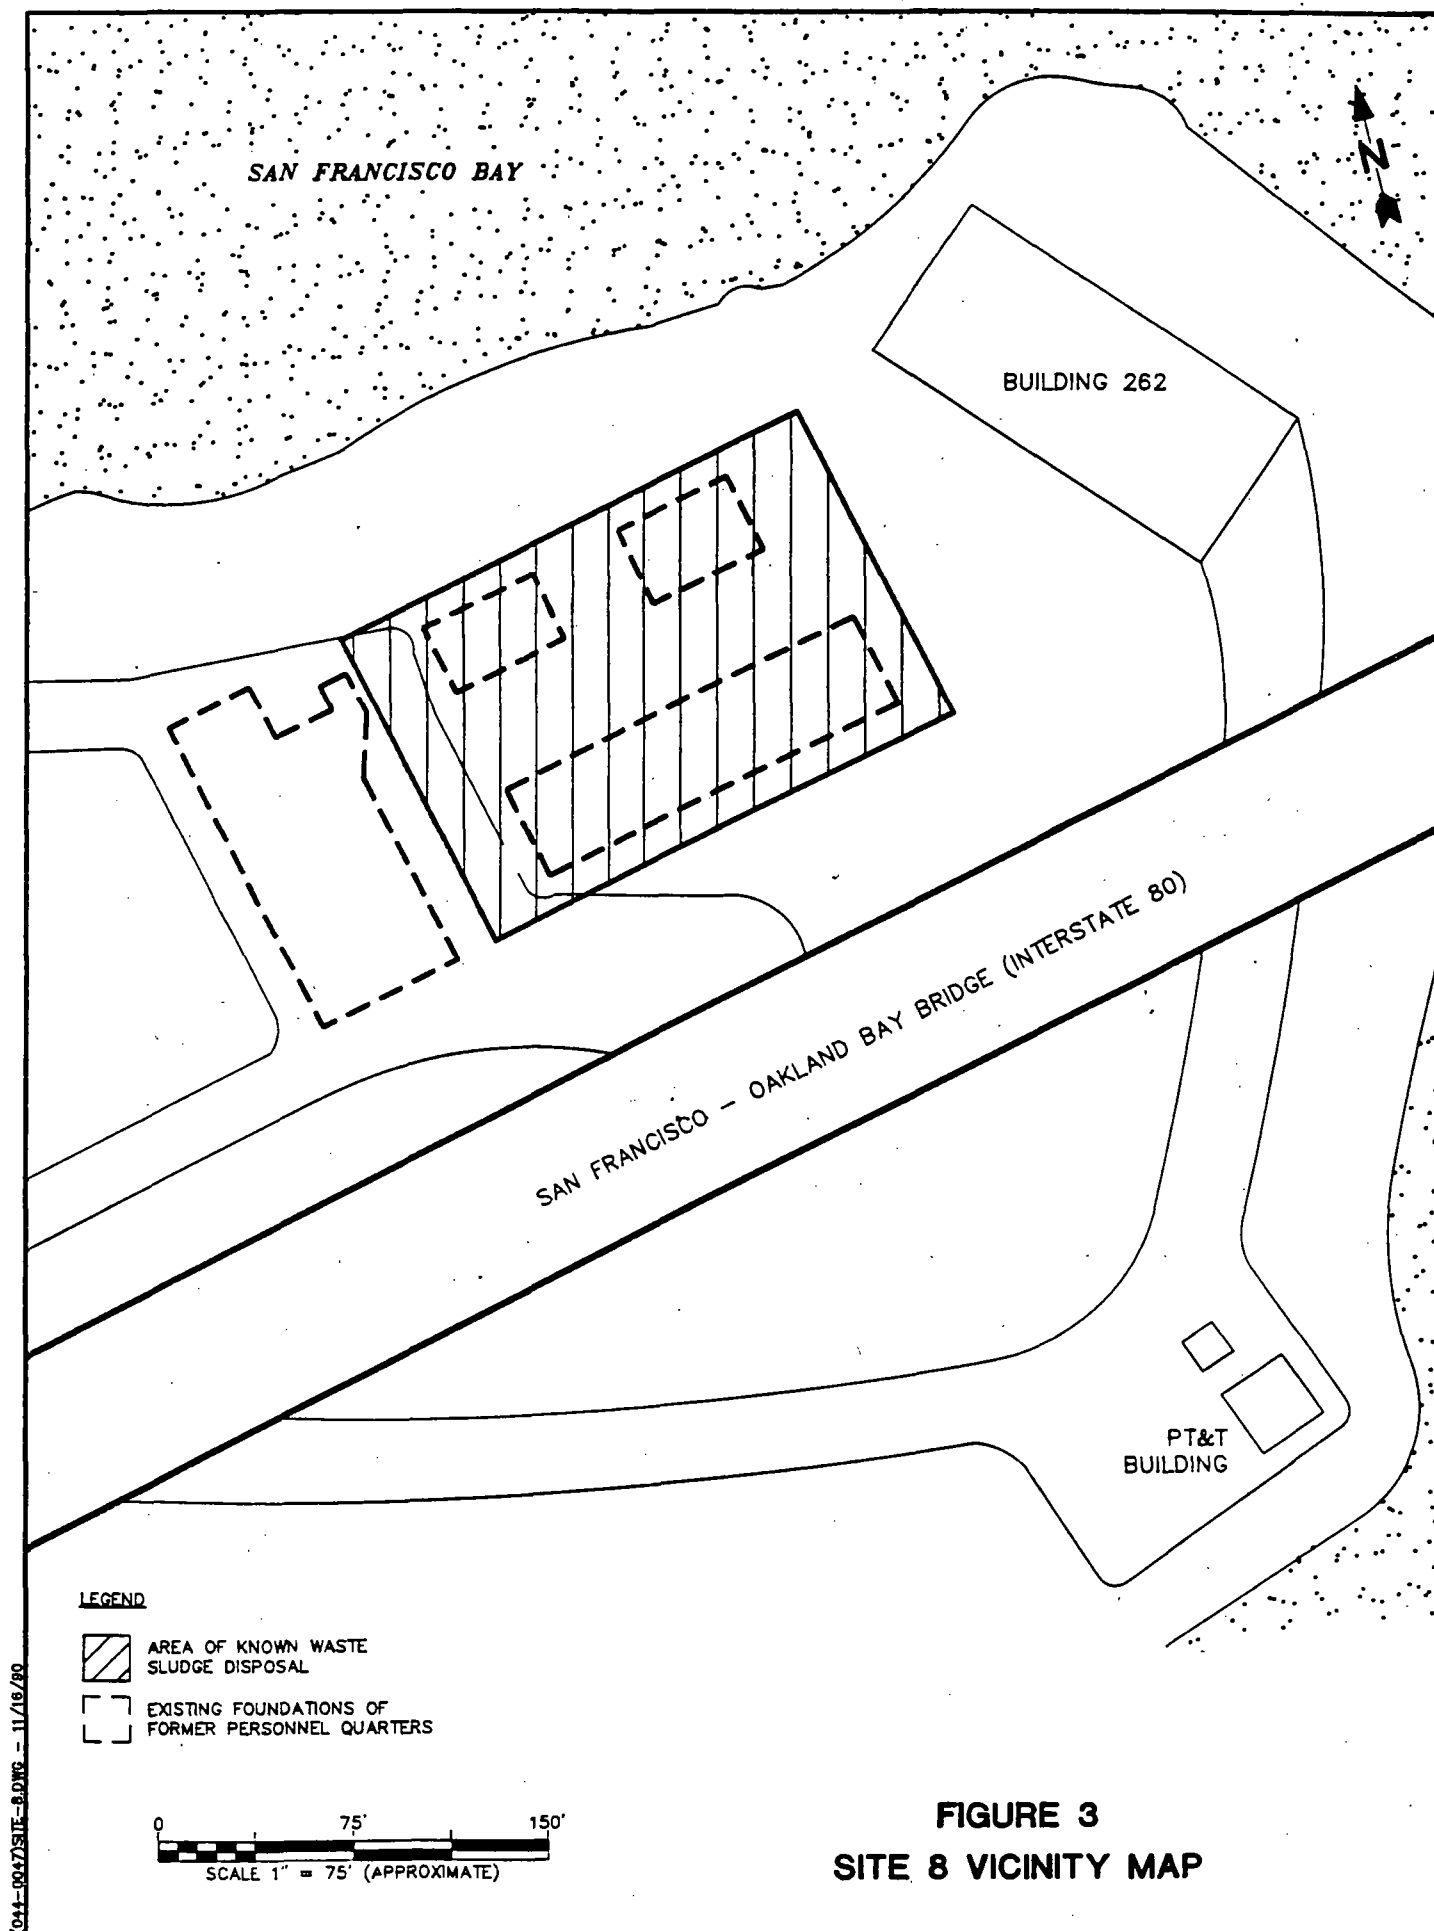
**FIGURE 3**  
**SITE 8 VICINITY MAP**

The Army Point Sludge Disposal Area is located west of Building 262 at the extreme eastern end of YBI. The site occupies a large, open area, approximately 100 feet by 400 feet in size (Figure 3). Army Point was formerly occupied by personnel quarters; however, only the concrete foundations of these structures remain. No activities are currently performed at this site, and the site is overgrown with small trees and shrubs.

Suspected contamination at Site 8 is the result of waste sludge disposal from the waste water treatment facility at TI. Waste sludge was also disposed of at another site, Site 7 - Pesticide Storage Area. Disposal activities reportedly occurred at Sites 7 and 8 from 1968 to 1976. Waste sludge disposed of at Site 8 was transported from the wastewater treatment facility and spread on the ground between the remaining foundations. The area of known waste sludge disposal is depicted in Figure 3.

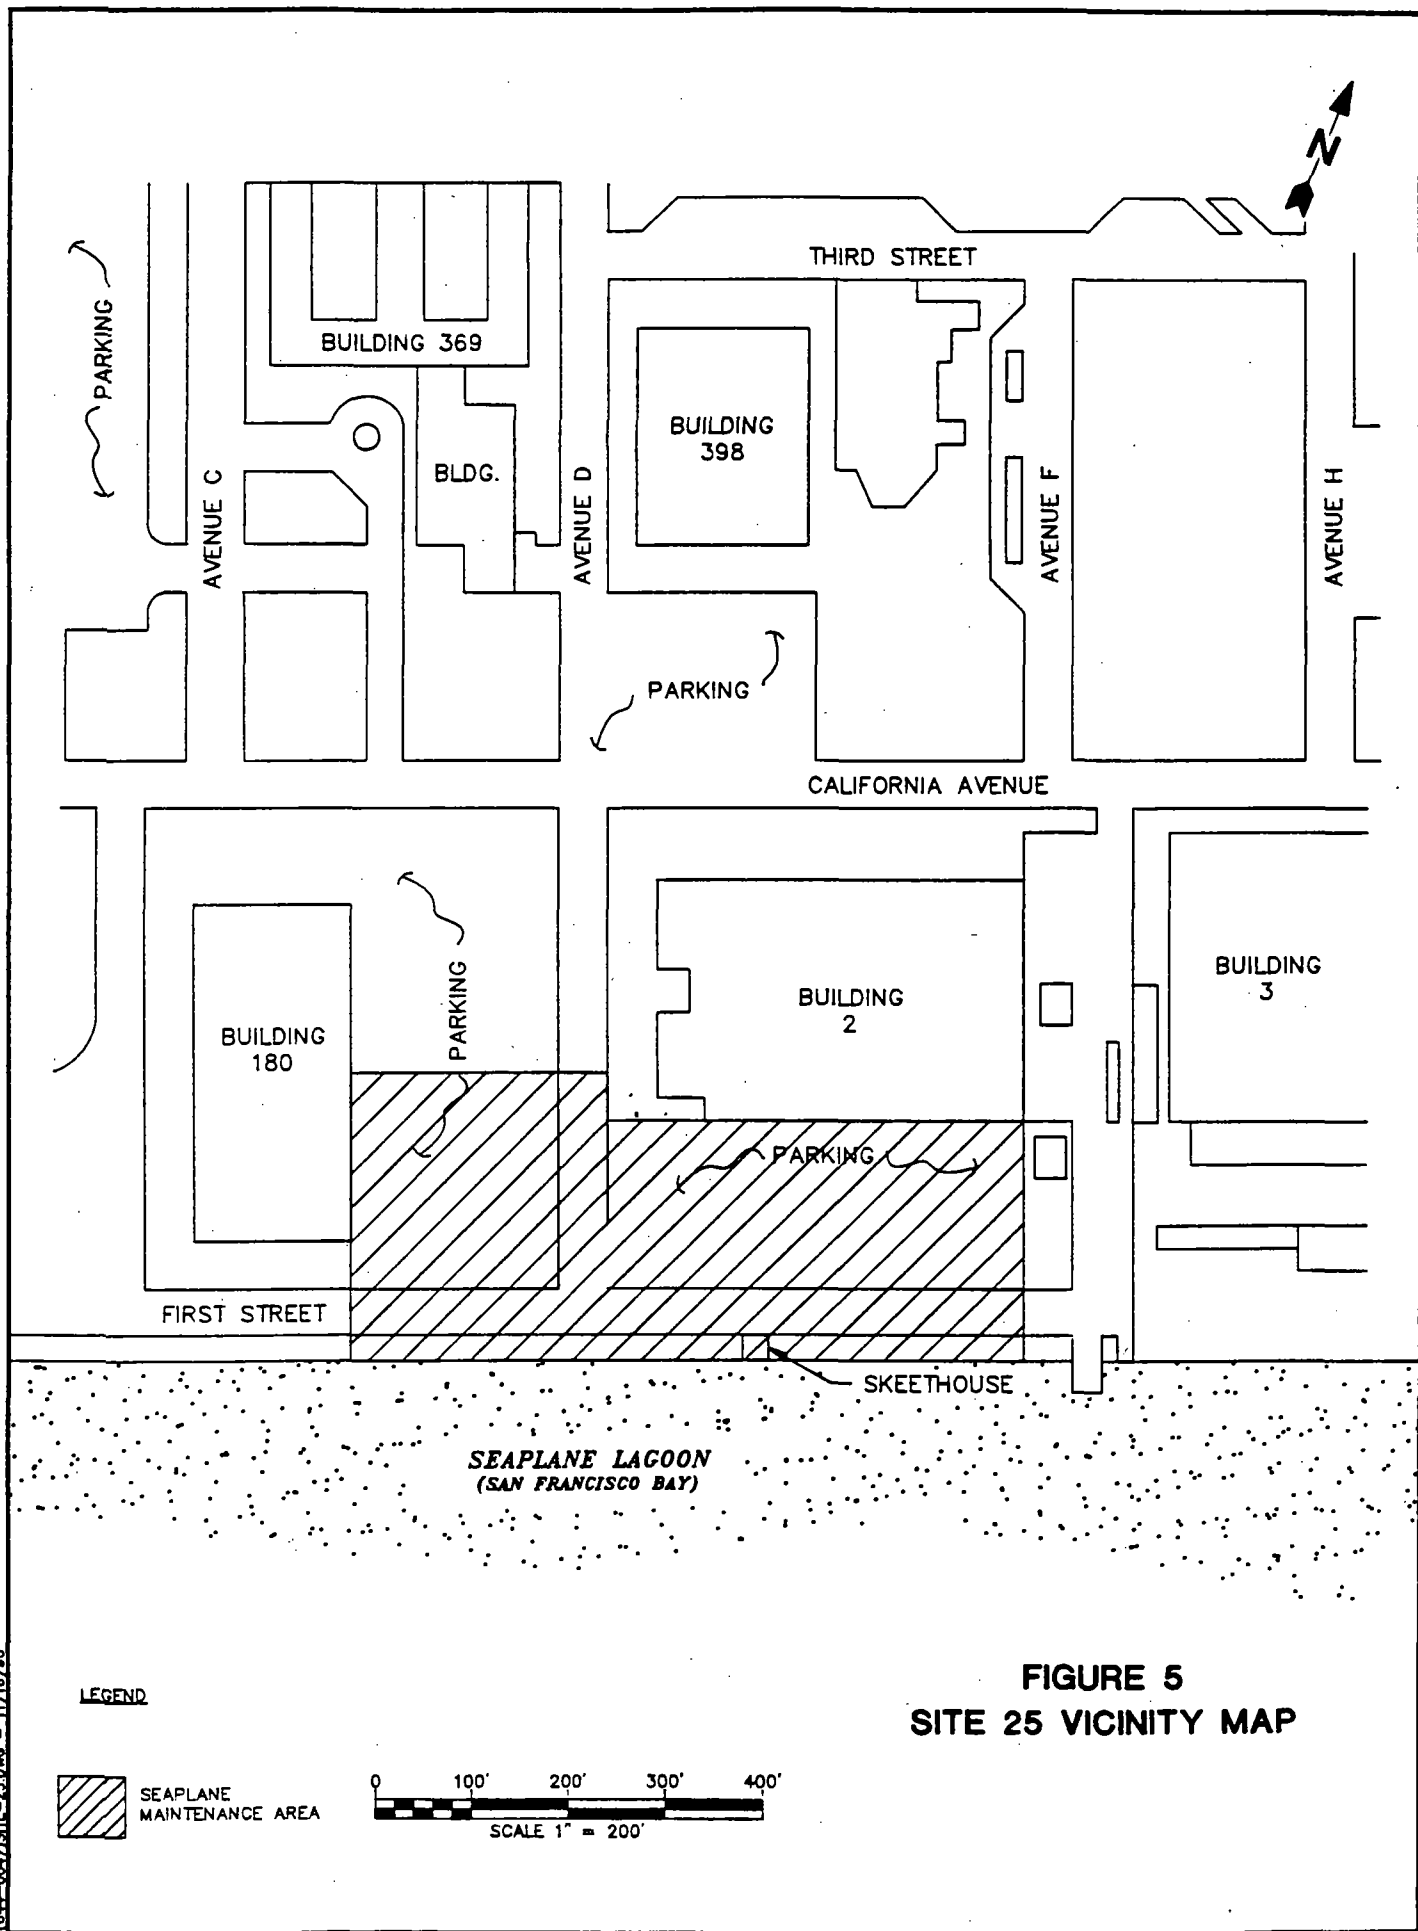
**FIGURE 5**  
**SITE 25 VICINITY MAP**

The Seaplane Maintenance Area is located at the southern end of TI, adjacent to and south of Buildings 2, 3, and 180 (Figure 5). These three buildings, constructed in the late 1930s, functioned as hangars for seaplanes from approximately 1943 to 1958. During this period, seaplanes were stored and maintained in and around the buildings; however, little information exists regarding the exact locations of these operations. Hazardous materials generated by these operations may include aviation fuel, engine oil, lubricants, and cleaning solvents. These hazardous wastes may have been disposed of on the ground, thereby contaminating the soil and, possibly, the ground water. Based on other practices known to have occurred at TI, an investigation was necessary to determine whether soil and ground-water contamination is present at the site.
